TECHNICAL MEMO

PRODUCT NAME: N4004(S), N6006, F401(s), F601 series camera
SUBJECT: Countermeasure of broken hook in camera back.

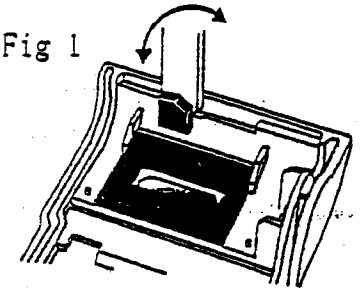
Fig 1

This is to inform you about countermeasure of broken hook in camera back.

1) Insert the bottom of tweezers into clearance in the back of broken hook. (Refer to figure 1)
